## CONSTRUCTION PROCEDURE FOR BEACH PROTECTION IN SÁNCHEZ MAGALLANES, TABASCO, MEXICO

Ramírez Cuevas José Miguel<sup>1</sup>, Zúñiga Malpica David<sup>1</sup>, Moreno Carpintero Enrique de  
Jesús<sup>2</sup>, Román Díaz Verónica<sup>3</sup>, Ramírez Cuevas Jesús Alberto<sup>4</sup>

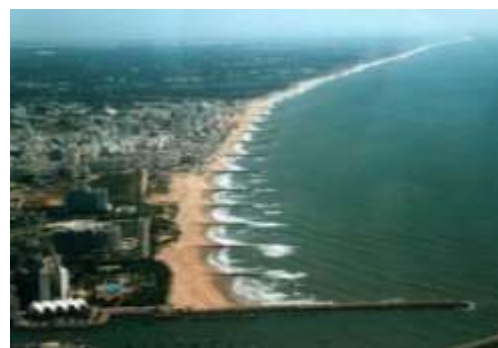
Breakwaters are structures that are generally built perpendicular to the coastline in order to prevent erosion caused by coastal transport, or to protect an area designated for a port that only needs protection at one point because it is located in a semi-sheltered natural area. [6], [7].

Figure 1. Breakwaters in the Algarve, Portugal (Portugal Travel Guide, 2013) [8].

Among the considerations for the construction of beach protection, it should be noted that the most commonly used material is rock. For example, in Figures 1, 2, and 3, it can be seen that for these constructions, which functionally serve as port and coastal protection, rock is the main material used. However, in the states of Tabasco and Campeche, it is difficult to find stone banks near the coast, so the use of this material increases the economic cost of the project. For this reason, it is necessary to seek alternatives in terms of materials that promote proper functioning and adequate economic savings, as well as correct construction processes.

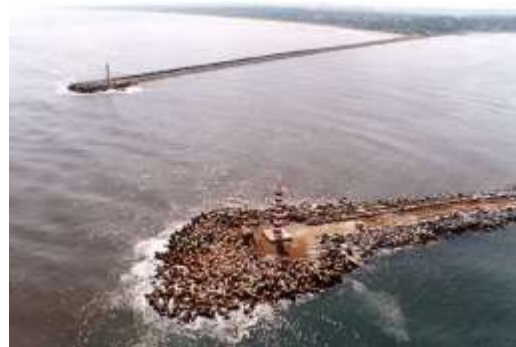
Breakwaters, on the other hand, are structures built and designed on the coast to channel or maintain contact between a body of water (river, lagoon, or estuary) and the sea, and to control coastal transport (siltation) and protect against waves. [5], [9].

Figure 2. Example of breakwaters in the port of Coatzacoalcos, Veracruz. (Ramírez, 2009).

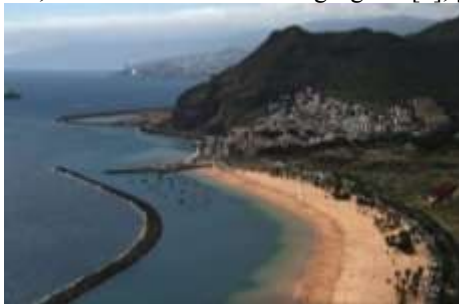
Breakwaters parallel to the coast are structures built for the purpose of reclaiming land from the sea and preventing its loss; they are built parallel to the

beach line, as shown in the following figure. [6], [9].

**Figure 3.** Example of a breakwater parallel to the coast, (Desonie, 2025) [10].

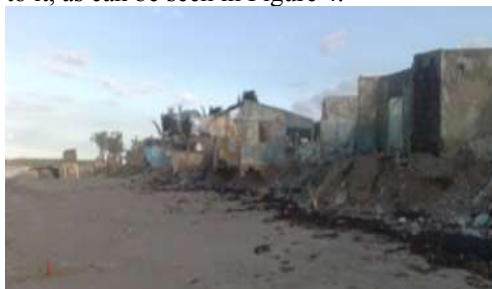
The problem in this area is the loss of beach land due to oceanographic conditions, resulting in a reduction in the area of the beach, as well as the loss of infrastructure close to it, as can be seen in Figure 4.

**Figure 4.** Image showing the damage caused by waves on the beach, which has damaged restaurants, homes, businesses, palapas, and streets in the community of Sánchez Magallanes, Tabasco.

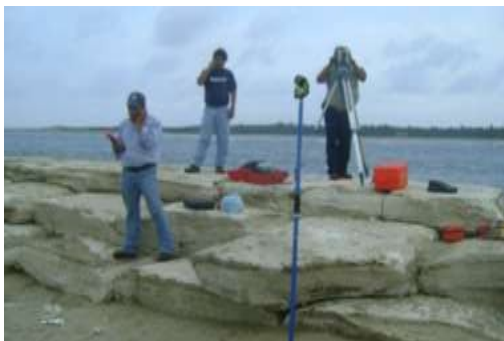
For the consideration of the works for the "Construction of beach protection in Sánchez Magallanes, Tabasco," a topographic survey was first carried out, as shown in Figure 6.

**Figure 6.** Figure showing the start of work with a topographic survey of the site where the work will be carried out in the community of Sánchez Magallanes.

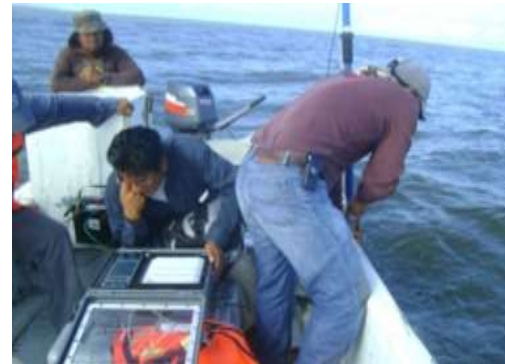
Subsequently, the bathymetric survey was carried out (Figure 7). These two surveys are essential for obtaining the heights, distances, areas, volumes, and levels of the work, and for specifying in detail the length and location where the geotextile fabric tubes will be placed.

**Figure 7.** Figure showing the bathymetric survey (measurement of sea depths to determine the topography of the seabed) with the appropriate specialized equipment.

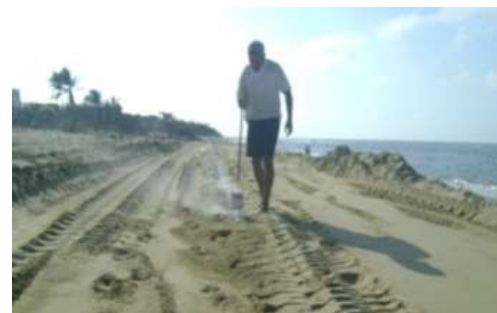
Once the respective surveys have been carried out, and the geotextile material and anti-scour mat are available for subsequent placement, the land is cleaned and leveled with the help of construction equipment such as a backhoe. After this, the line where the tubes will be placed is marked out (Figure 8).

**Figure 8.** Figure showing the cleaning of the beach protection site, as well as the leveled ground and a person marking the line where the anti-scour mat and geotextile pipe will be placed.

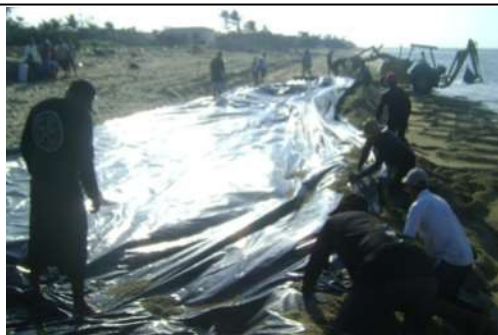
Once the above has been done (cleaning, leveling, and marking), the anti-scour mat must be laid, which will serve to prevent beach erosion in the area of the geotextile pipe, which will be placed later, once the anti-scour mat is in place (Figure 9).

**Figure 9.** Placement of the anti-scour mat in the area and length where the geotextile tube will subsequently be placed.

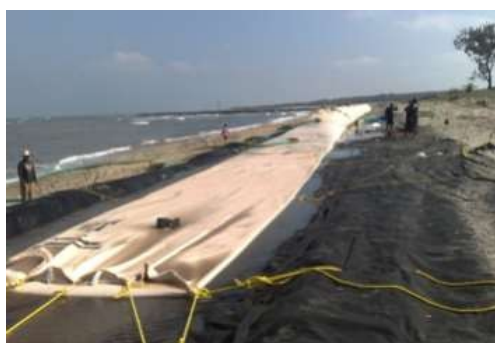
After placing the anti-scour mat, the geotextile tubes are placed and filled with water and sea sand (Figure 10).

**Figure 10.** Figure showing the anti-scour mat already in place and the start of the installation of the geotextile tube to be filled with water and sand.

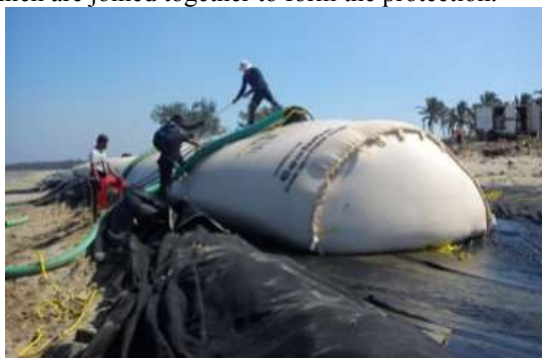
The above activity is carried out using a pump. 7.5 HP, which sucks up seawater and suspended sand, allowing the sand to remain inside the tube and the water, being liquid, to flow out (Figure 11). This process is carried out with each of the geotextile fabric tubes, which are joined together to form the protection.

**Figure 11.** The laying and placement of the anti-scour mat and the filling of the geotextile fabric tube on top of the mat can be seen. The geotextile fabric tube is filled with water and sand using the 7.5 HP pump. The sand remains inside the tube, while the water flows out.

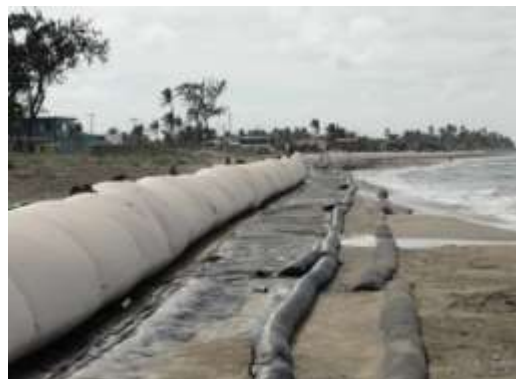
Once the above has been carried out as part of the construction process, progress is made and the beach protection is formed. Figure 12 shows the placement of geotextile fabric tubes on top of the anti-scour mat along the length of the project, as well as the progress of the project on the beach in the town of Sánchez Magallanes, Tabasco, Mexico.

**Figure 12.** Geotextile fabric tubes on top of the anti-scour mat. Visualization of the project, its progress, and length at the construction site.

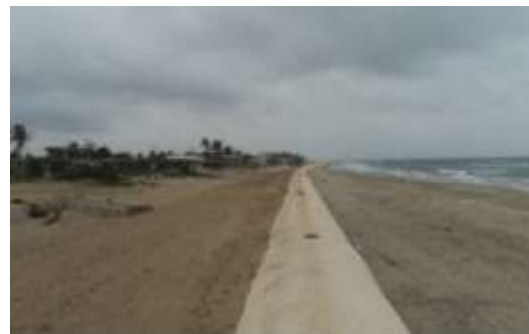
As an example of the completion of the work, Figure 15 shows the completed work, presenting the best alternative to the problem presented in this community, in addition to mentioning that at the end of the work, sand was filled behind the geotextile fabric pipes (reloading of beach material).

**Figure 15.** Figure showing the completion of beach protection works using geotextile fabric tubes, as well as sand filling on the beach in front of the geotextile fabric tubes.

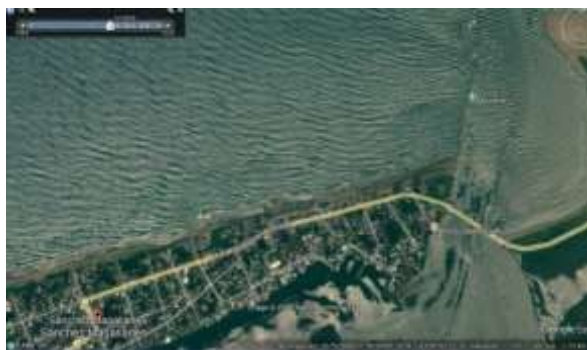
The following figure shows the condition of the beach in the community of Sánchez Magallanes, Tabasco, Mexico.

**Figure 16.** Initial state of the beach in 2009 with beach loss in the community of Sánchez Magallanes, Tabasco, Mexico.

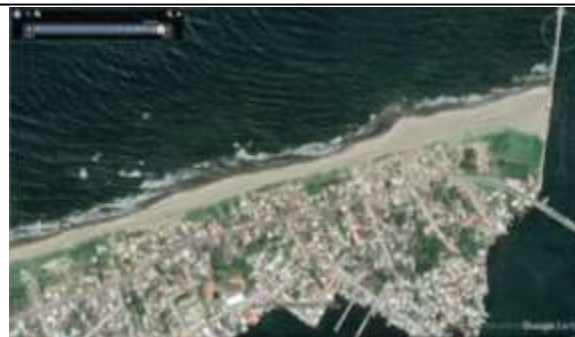
Similarly, it can be concluded that beach protection is currently maintained in favorable conditions despite oceanographic events and phenomena that occur on the coast, such as waves, currents, winds, tides, and storms and cyclones. For example, from 2012 to 2021, the condition of the beach and its protection using geotextile fabric tubes has remained good (Figure 17).

**Figure 17.** Figure showing the good physical condition of the beach protection and the material recovered from it in 2021, in the community of Sánchez Magallanes, Tabasco, Mexico.
